Engine Support Bar:

Oil Seal Arbor:

Cam Securing Fixture:

Special Coned / Splined Oil Seal Remover:

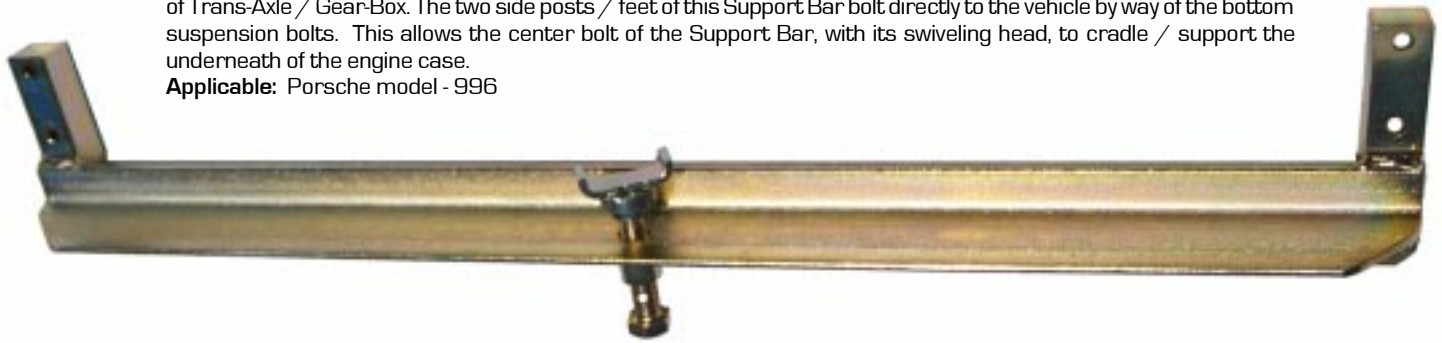
P 254

This special service tool was developed for the crucial task of supporting the engine within its compartment during R&R of Trans-Axle / Gear-Box. The two side posts / feet of this Support Bar bolt directly to the vehicle by way of the bottom suspension bolts. This allows the center bolt of the Support Bar, with its swiveling head, to cradle / support the underneath of the engine case.

Applicable: Porsche model - 996

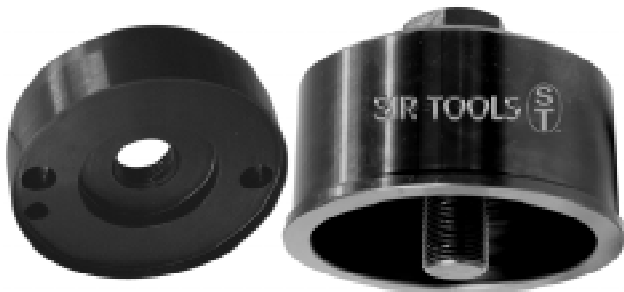
P 250

This special service tool was developed for the proper installation of oil seal on "Flywheel" side of crank shaft. To do this task with any other method is risking a total engine failure by way of a damaged oil seal.

Applicable: Porsche model - 996 & Boxster.

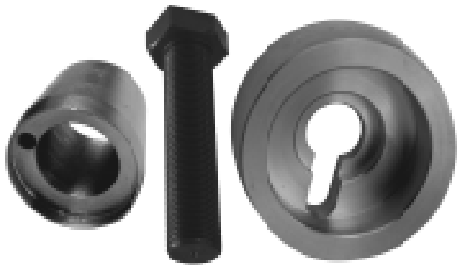
P 251

Oil Seal Arbor:

This special service tool was developed for the proper installation of oil seal on "Pulley" side of crank shaft. Trying to do this task with any other method is risking a total engine failure by way of a damaged oil seal.

Applicable: Porsche model - 996 & Boxster.
